FACILITY COMPLIANCE INSPECTION REPORT

Date of Site Inspection: 15 March 2012

Larry Styron LCID Landfill
Herring-Smith Road
Newport, NC 28570

Site visit to review continued measures taken in response to 2 January 2012 fire event

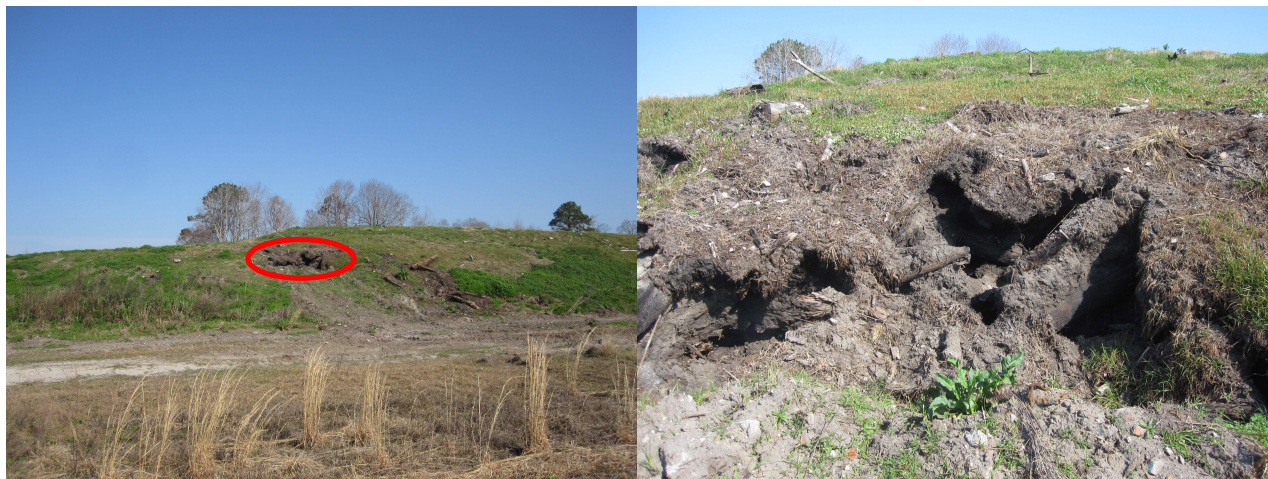
- 11) The repaired area on the southeast sideslope of the landfill has given way and a hole was present in the landfill cap measuring approximately 6' x 5' and 2'-3' deep. *This area is a hot spot and must be filled with soil and compacted as

Hot area on the southeast sideslope

soon as possible. **Due to the danger of cave-in, special care should be taken with any heavy equipment use on or around the landfill.**
